Virginia Station Needs Assessment

DRPT initiated a study to identify the condition and needs at Virginia's Amtrak stations.

DRPT VIRGINIA STATION NEEDS ASSESSMENT

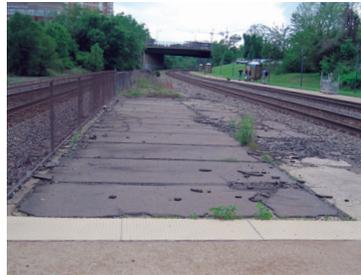
Asphalt and concrete damage apparent on both platforms.

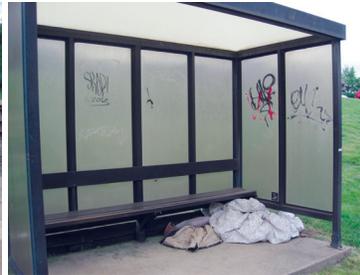
Shelters along platform have graffiti and litter.

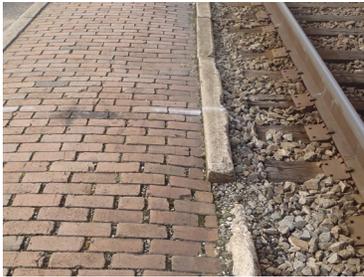
East platform shows curb damage and irregular curvature.

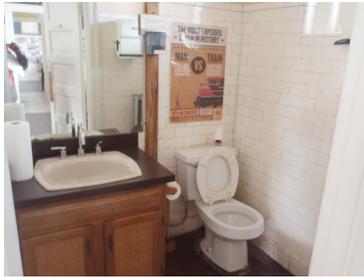
Restrooms are not ADA compliant.

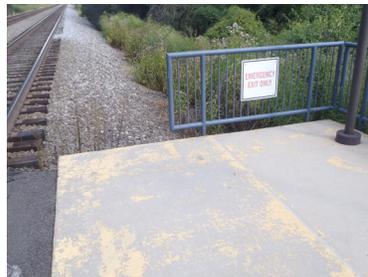
Platform emergency egress on eastside is unsafe.

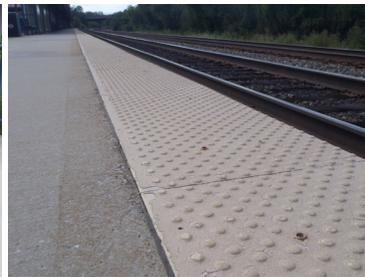
Platform tactile strips are faded and cracking.

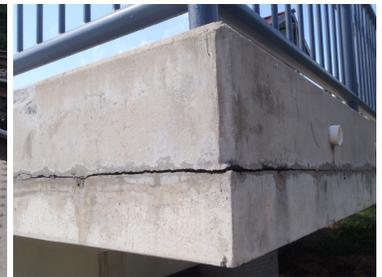
Concrete ramp is cracking.

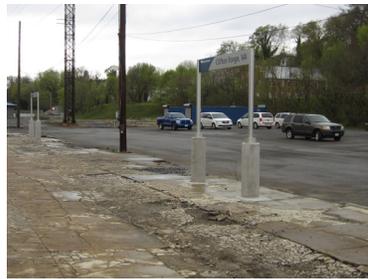
Concrete slabs at the boarding area show substantial cracking.

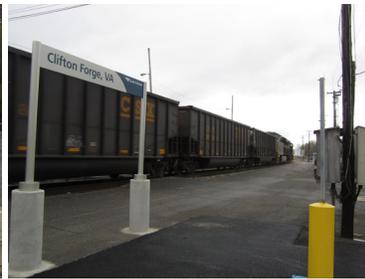
The boarding area lacks a platform.

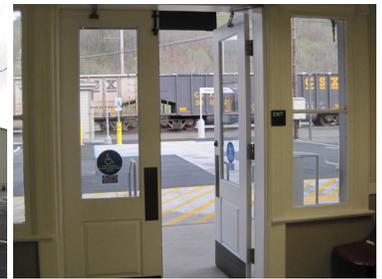
Building door does not open 90 degrees with ADA push button.

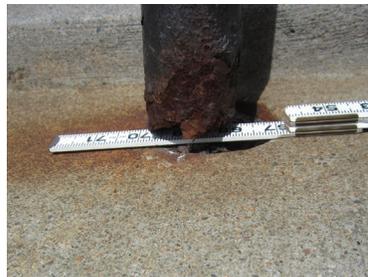
Platform railing is rusted to complete section loss.

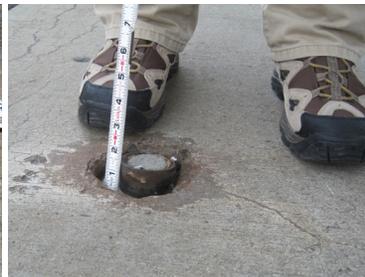
Exposed tubes pose as tripping hazards on the platform.

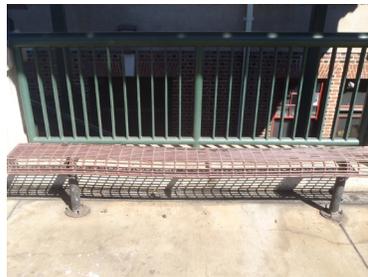
Benches on the platform are not ADA compliant.

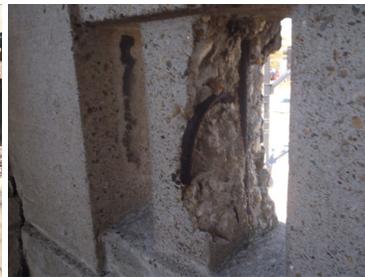
Concrete on platform structure shows major signs of wear.

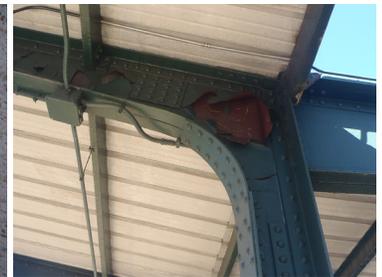
Paint on the canopies is flaking.

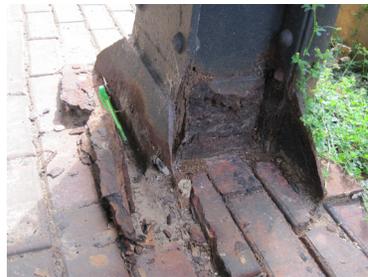
Base column of stairs is rusted.

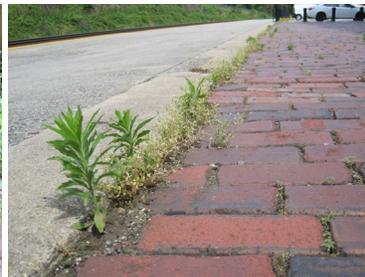
Vegetation is growing throughout platform adjacent to station building.

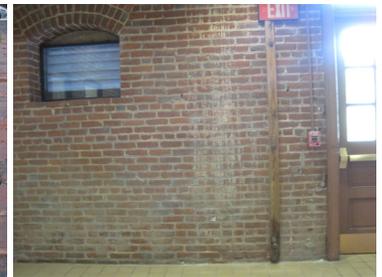
Ceiling and brick walls show signs of leaking.

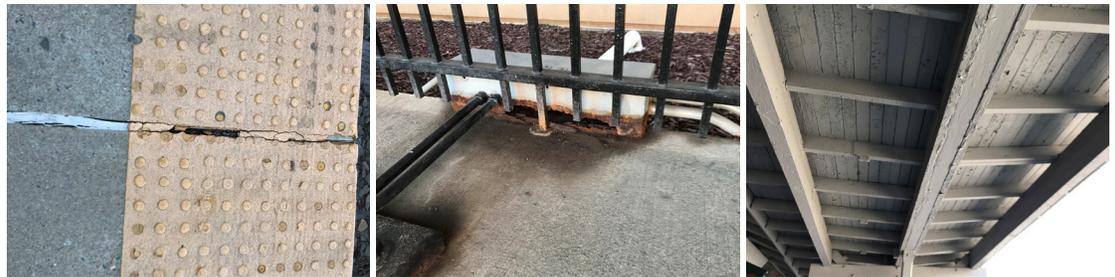
Joint sealants between concrete slabs on platform need replacement.

Electrical boxes behind platform are heavily rusted.

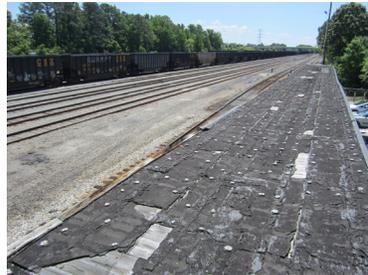
Plastic on top of canopy is loose and deteriorating.

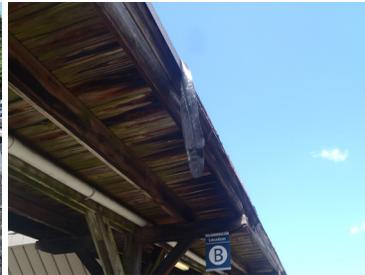
Wood canopy columns are water logged and separating.

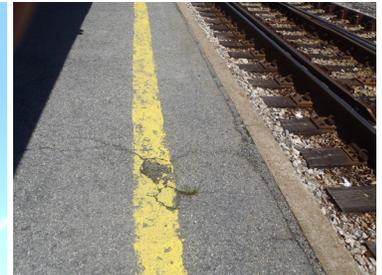
Asphalt on platform shows wear and lacks tactile strips.

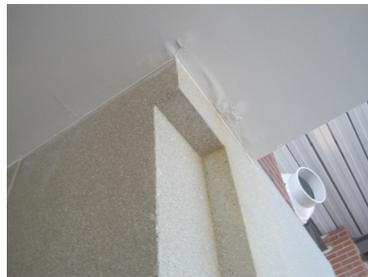
Evidence of water damage on the ceilings of the waiting area.

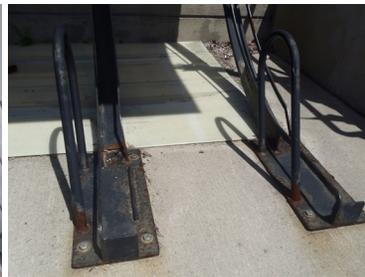
Bike storage racks are rusted at the base.

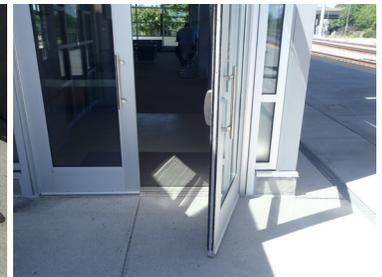
Door leading to platform does not open 90 degrees with ADA push button.

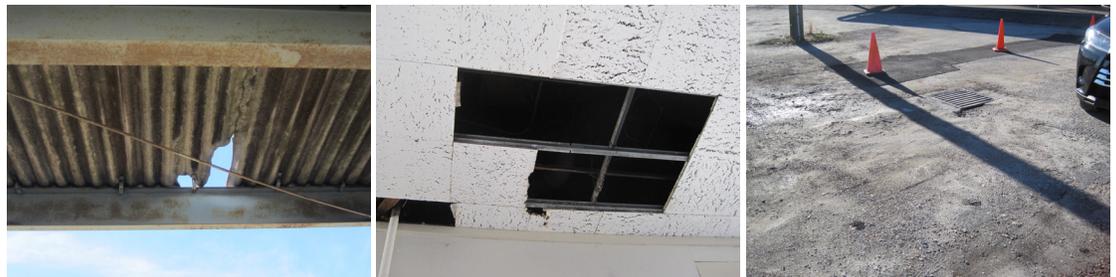
Canopy contains numerous holes. Ceiling in the crew area is missing panels; shows signs of leaking. Parking lot has drainage issues, uneven asphalt, potholes.

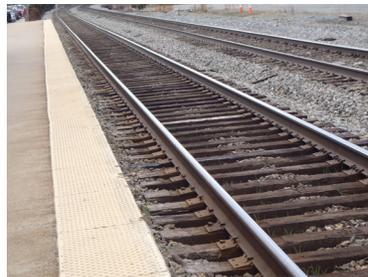
Tactile strips are faded and a large portion is chipping/broken.

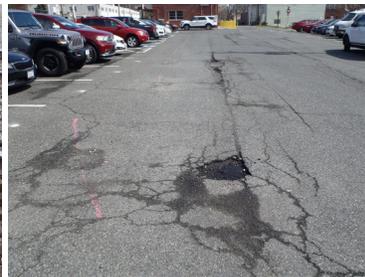
Parking lot contains many potholes.

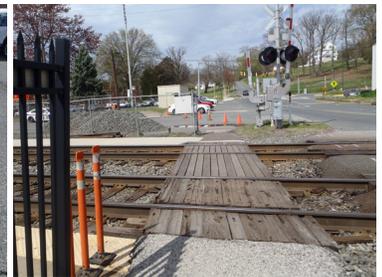
Wooden pedestrian crossing is wobbly and poses a tripping hazard.

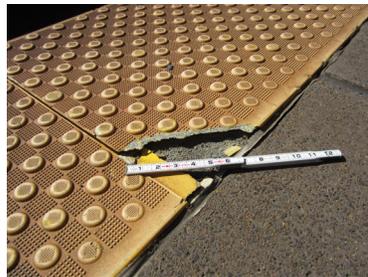
Portions of tactile strips pose a tripping hazard.

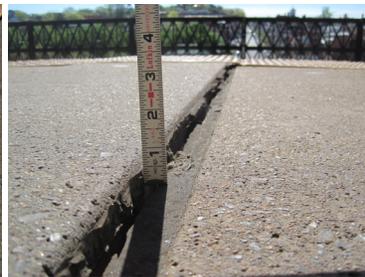
Concrete slabs are uneven on the platform.

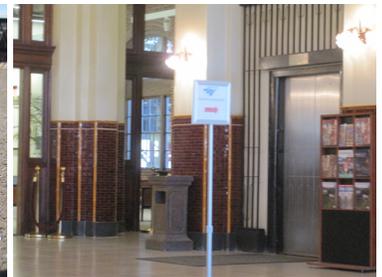
A lack of standardized wayfinding signage for pedestrians inside the station.

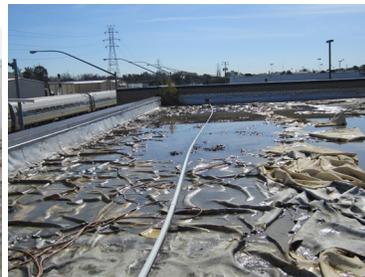
Standing water on the roof results in leaking in waiting area and crew areas.

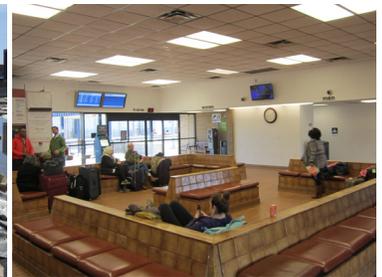
Overcrowding occurs in waiting area during train arrivals.

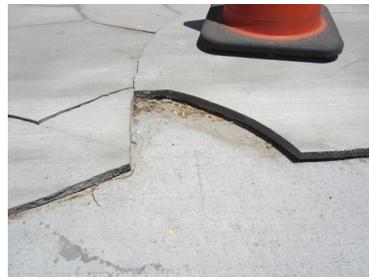
Concrete is damaged towards west end of platform.

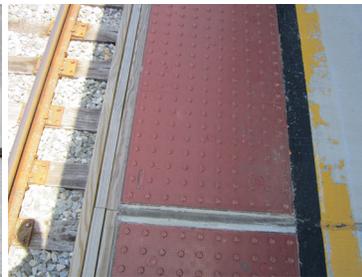
"Stay behind yellow line" paint is faded.

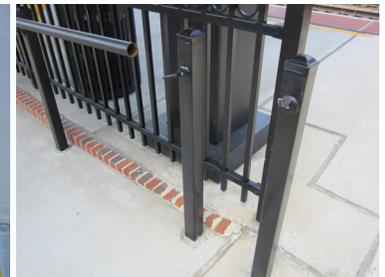
Hand rail on the east end of the platform ramp is missing.

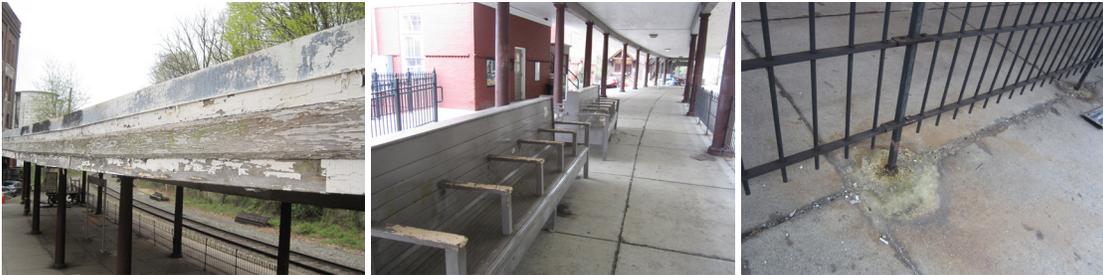
Canopy paint is flaking off. Some panels are not painted at all. Paint on the platform benches is wearing away. Rusting and corrosion at the base of platform railing.

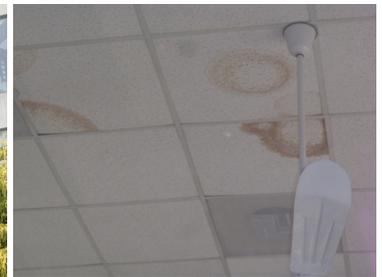
Ceiling in snack area shows signs of leaking.
