Virginia Station Needs Assessment

DRPT initiated a study to identify the condition and needs at Virginia's Amtrak stations.

DRPT VIRGINIA STATION NEEDS ASSESSMENT

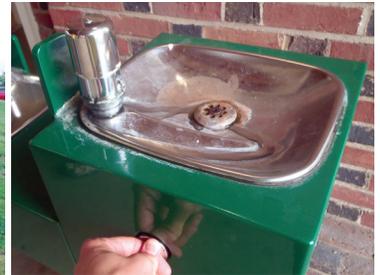
Water fountains are clogged/unusable.

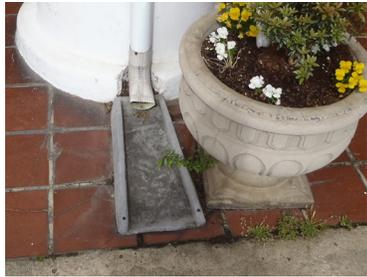
Downspouts lead to platform with poor drainage system.

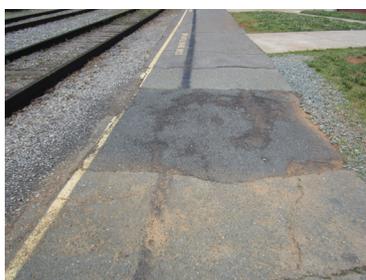
Platform surface is uneven with evidence of standing water.

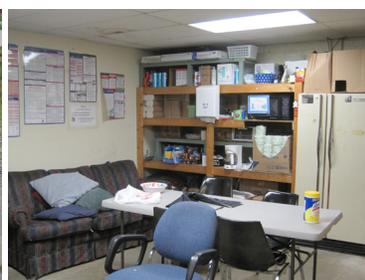
Appliances are precariously located in the crew area.

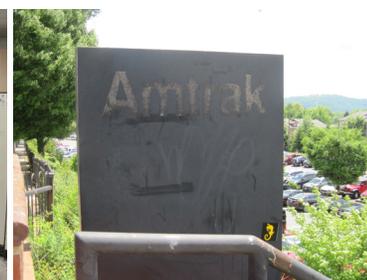
Amtrak station sign is heavily faded.

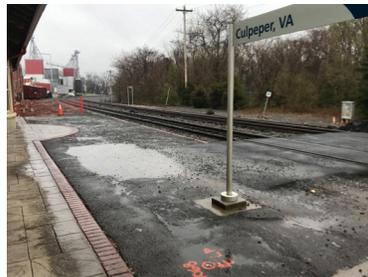
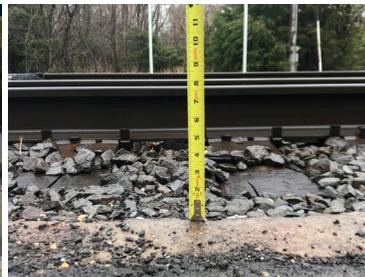
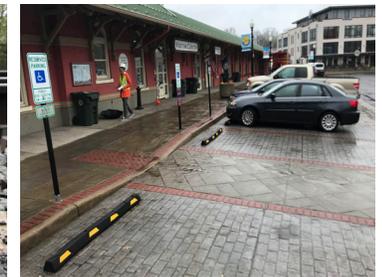
Platform has major drainage issues. Platform is well below top of rail. ADA spaces are for short term parking only.

- An ADA compliant platform is currently being built as part of an Amtrak ADA improvement program. This platform will be 380 ft. long and 8 inches above the top of rail when completed
- Amtrak has periodically been replacing and repairing brickwork on paths around the station property for ADA compliance

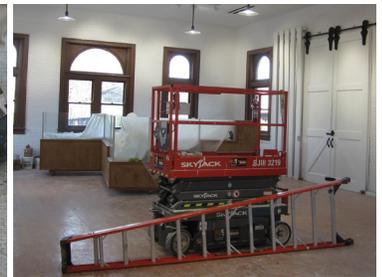
Due to renovation, the passenger waiting area at time of inspection was closed.

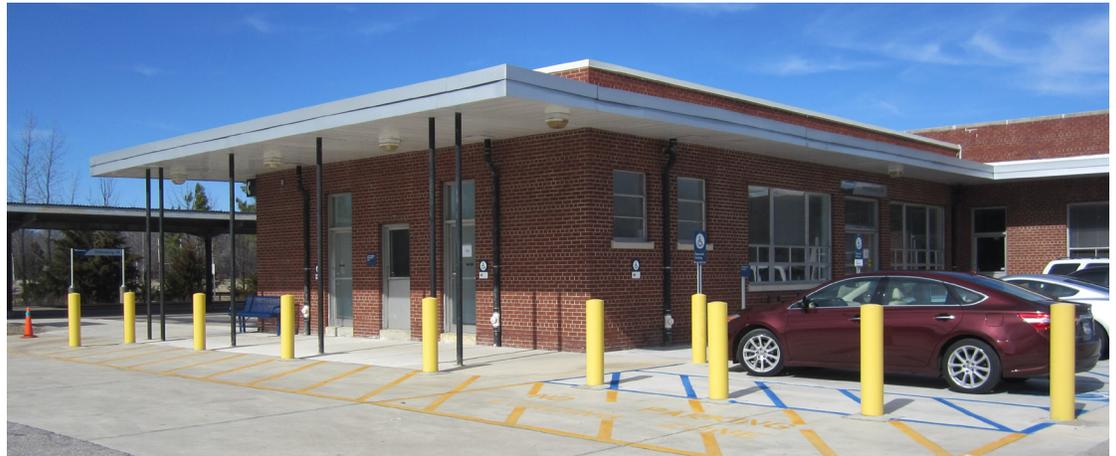
Looking north. Site visit conducted February 13, 2019.

Canopy contains numerous holes. Ceiling in the crew area is missing panels; shows signs of leaking. Parking lot has drainage issues, uneven asphalt, potholes.

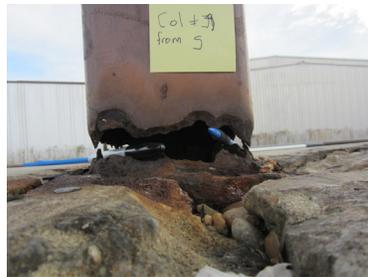
Some canopy columns have 100% section loss at the base.

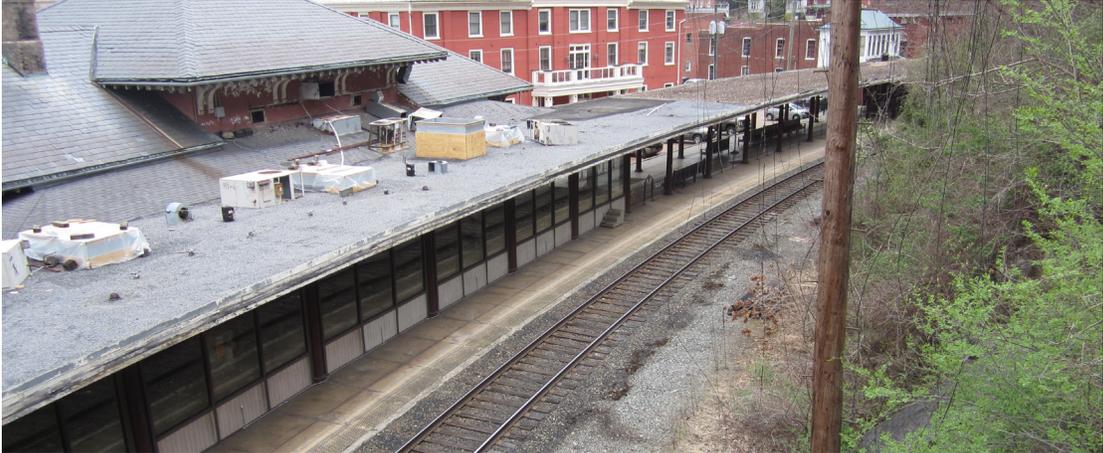
Looking northeast. Site visit conducted April 12, 2019.

Canopy paint is flaking off. Some panels are not painted at all. Paint on the platform benches is wearing away. Rusting and corrosion at the base of platform railing.

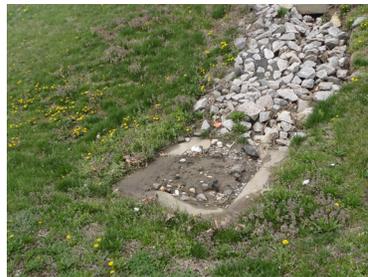
Grate behind platform is completely blocked with debris.

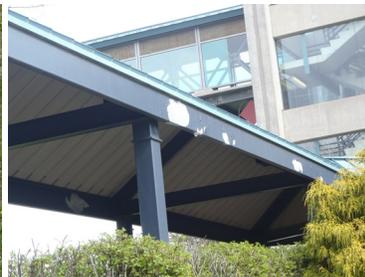
Walkway canopy is chipping paint.
